MAVAM ESPRESSO, LLC

TECHNICAL DOCUMENT

4014 Leak on a Group Head that takes out Cartridge Heater or SSR

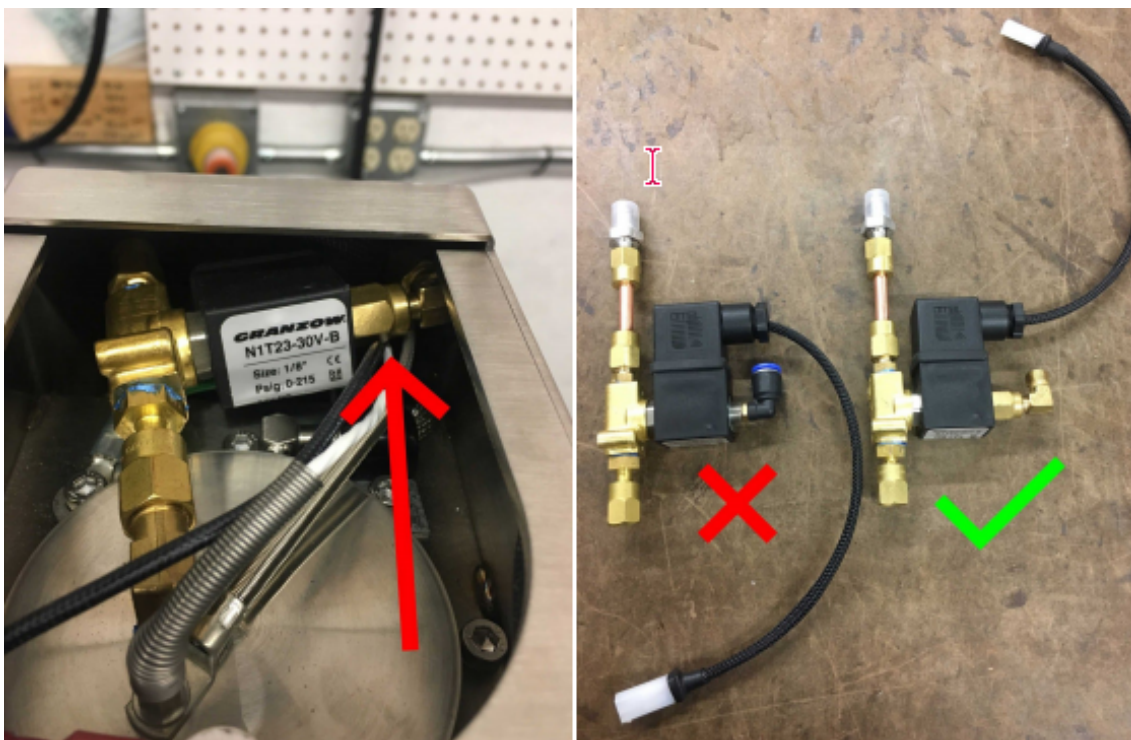
If you have the brass exhaust fittings and have found a leak on top of the group there are a few things to check. In some cases a bad leak on top of the group may short the cartridge heater and in some rare cases may also take out the SSR.

- Remove the BU front panel and shut off the specific group. Then, run pre-infusion, no pumps should activate, and then remove the brew valve, tighten or replace the brew valve exhaust fitting as required. Clean up the top of the group so you can easily spot a leak in the future.

If the heater is not heating or overheating, once the water leak is fixed and cleaned click the high limit switch. If the cartridge heater is still not heating or very visible water damage now you can replace the heater.

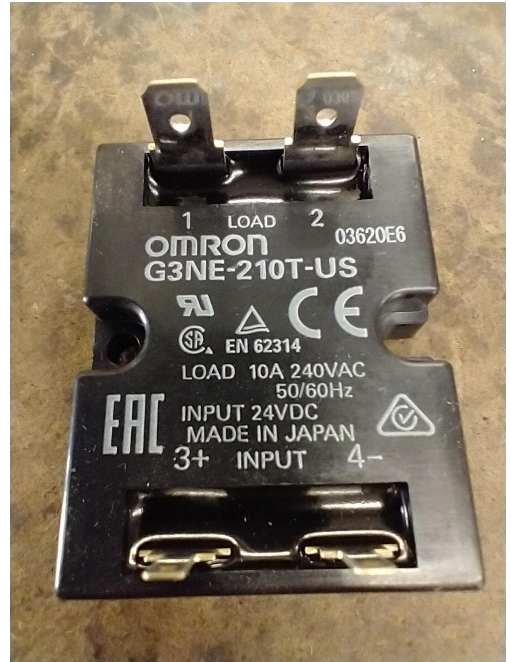
If you have replaced the heater and the group is still overheating you may need to replace the 24v SSR. [The relay layouts for the Under Counter machines are here.](#)

- a. Make sure the machine is turned off, transfer connections to the new corresponding SSR in the layout. Unscrew old, there will be thermal paste, apply more if needed. Reuse the same screws and tighten it securely.
- b. Now turn the machine back on to check that the group is now heating properly.

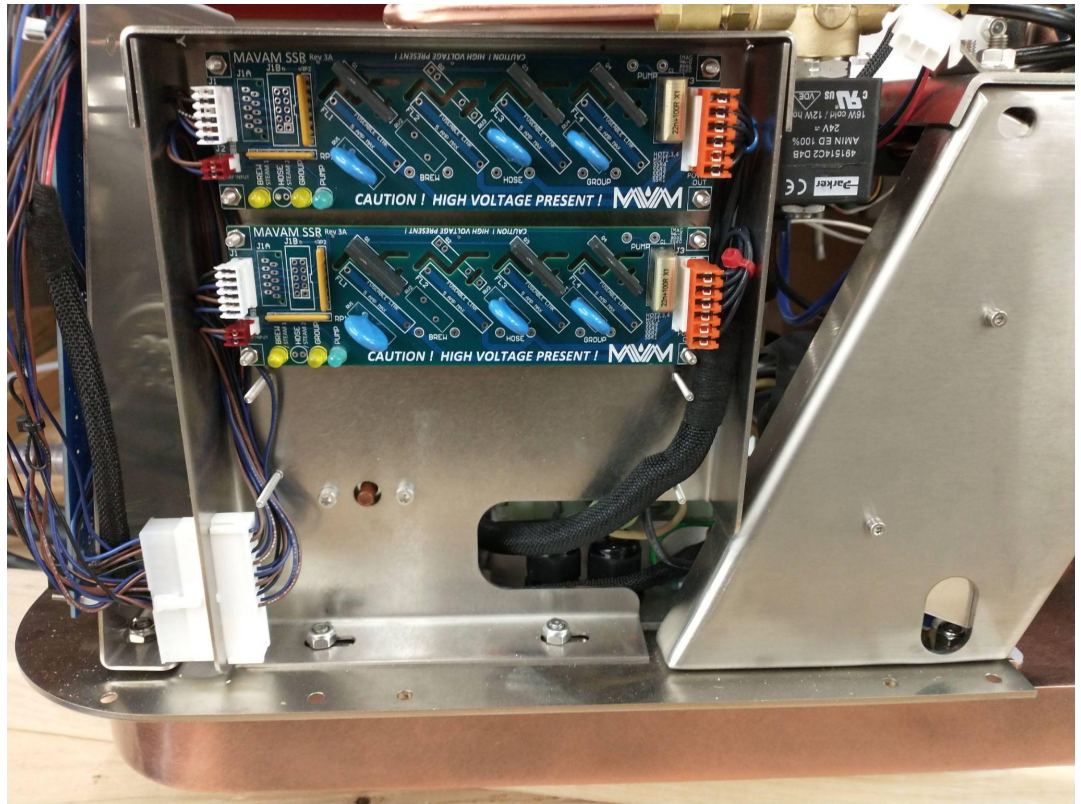
The Mach Two has a relay board per group and this will need to be replaced for the appropriate group. Group 1 starts at the top to the lowest depending on how many groups.

- a. **Turn off and unplug the machine.**
- b. Undo the wired connections and apply them exactly the same on the new board. You may now unscrew the nuts holding the old board on the bracket, 4 per relay board, and replace with new and wired relay board.
- c. Now turn the machine back on and test that the group is now heating properly now.
